# Investigation of crack initiation during the burst test of hydrogen storage composite overwrapped pressure vessels

Changchen Liu<sup>ID</sup>, Zhihui Ouyang, Jiexiang Yu and Li Ma\*

Institute of Applied Mechanics, Zhejiang University of Technology, Hangzhou 310018, China

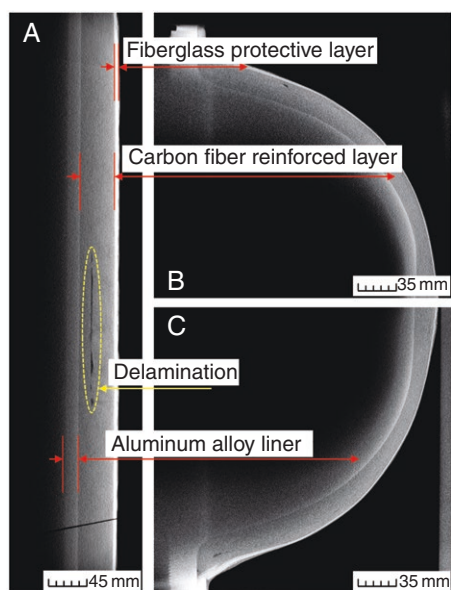
Generally, the brightness of a CT image is proportional to the density of the material, so different materials will present slightly different brightness, making it easier to discern delamination defects. Figure 3 shows the CT scanning results of the COPV. Through the scanning image, the overall structure of the COPV can be clearly seen: an aluminum liner, a carbon fiber composite reinforcement layer, and a glass fiber composite protective layer from inside to outside. The delamination defect in the cylinder part is indicated by the yellow circle in Fig. 3a, and the size and location of the defects can be measured and counted based on the scanning result.

Figure 3. CT scan results correspond to different parts of the COPV.

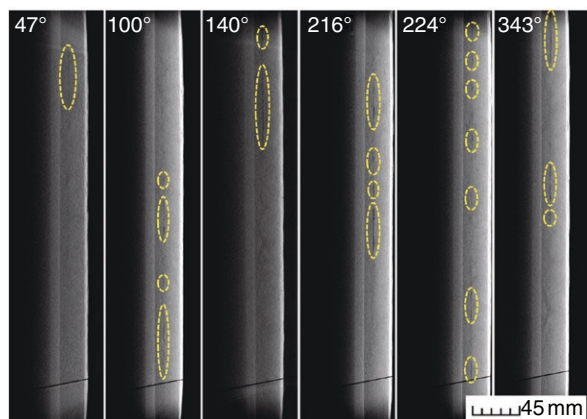
Figure 4 shows the cross-section of the cylinder part with different angles. It finds that there are indeed a large number of delamination defects with random locations and dispersed sizes inside the fiber wound layer of the COPV.

Figure 4. Delamination defects in cylindrical part.

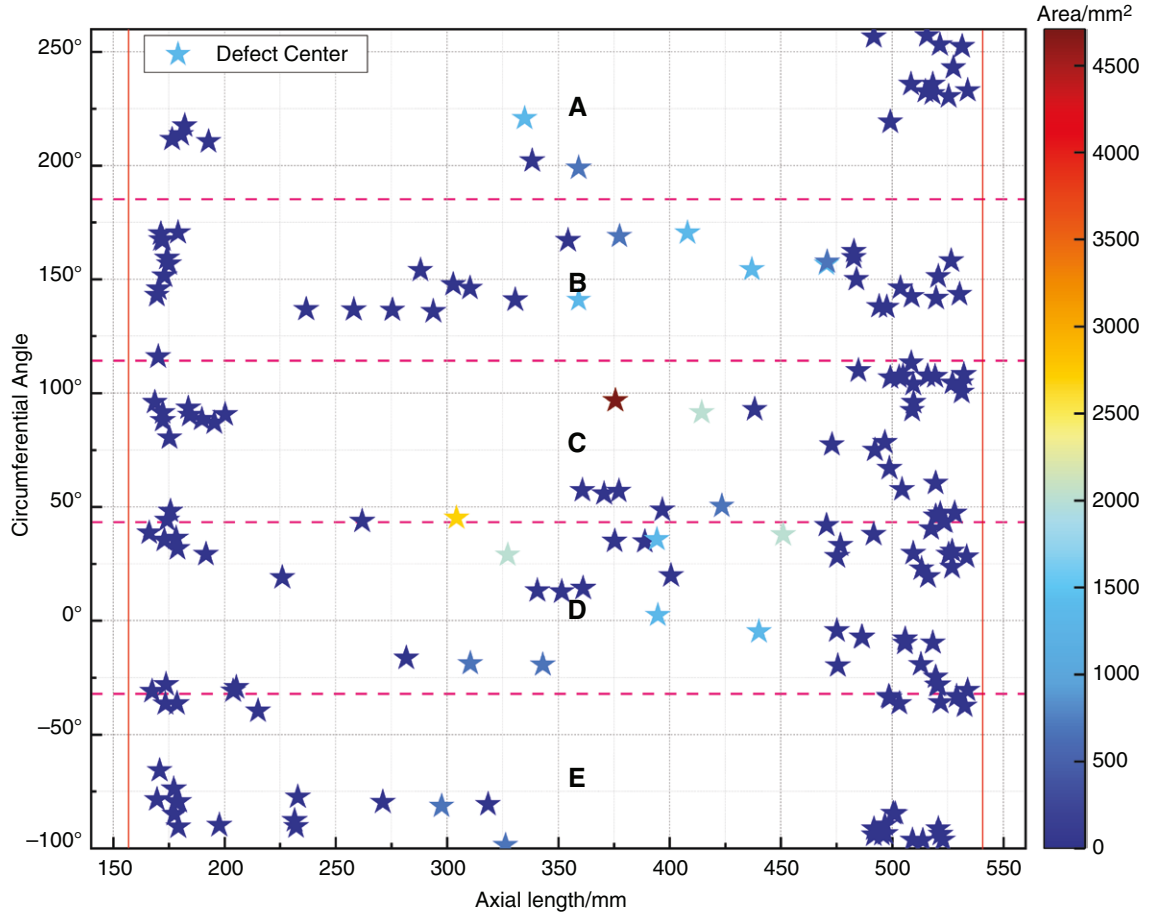
Figure 6 shows the statistical information of the position and area of the delamination defects in the cylinder part of the COPV, in which the horizontal coordinate corresponds to the axial length and the vertical coordinate is the angle corresponding to the annular unfolding. It can be found that there are a large number of small-size delamination defects in the transition region between the cylinder part and the dome, which is mainly caused by the change of the surface curvature in the transition region. Combined with Table 1, it can be found that the number of delamination defects in the middle section of the cylinder part is small, but the average size is large. On the other hand, the transition region on both sides has a large number of delamination defects, but they are small-sized delamination defects. By analyzing the relevant data, it is found that there are 164 delamination defects with an area of  $<500 \text{ mm}^2$  (accounting for 87.7% of the total number of defects). Nevertheless, the area of the defects only comprises 19.14% of the entire defects area, and its impact on the overall mechanical property is negligible. Therefore, further statistics of the delamination defects with an area greater than  $500 \text{ mm}^2$ , as depicted in Fig. 7, reveal that the number of defects obeys a normal distribution. These defects account for 80.86% of the total defect area and are primarily concentrated in the middle section of the cylinder part. It is inclined to cause stress concentration, which in turn adversely affects the overall mechanical properties of the structure.

**Figure 6.** Distribution and areas of delamination defects in the COPV.

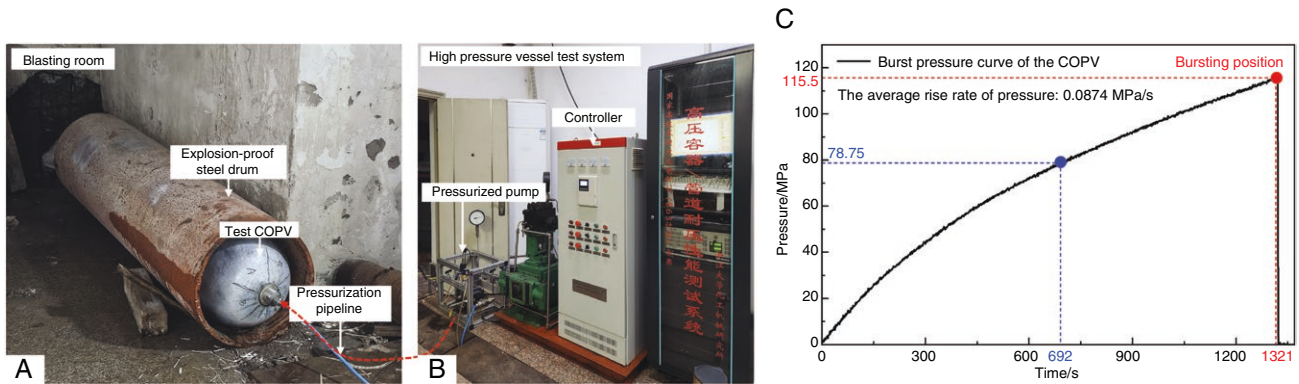
During the test, the internal pressure of the COPV was monitored in real time by the high-pressure vessel/pipe pressure resistance testing system. The resulting pressure curve, shown in Fig. 8c, indicates the average pressure increase rate of 0.0874 MPa/s and the burst pressure of 115.5 MPa.

Figure 8. Burst test of COPV: (a) overview of the experimental setup; (b) the high-pressure vessel/pipe pressure resistance testing system; (c) pressure curve.

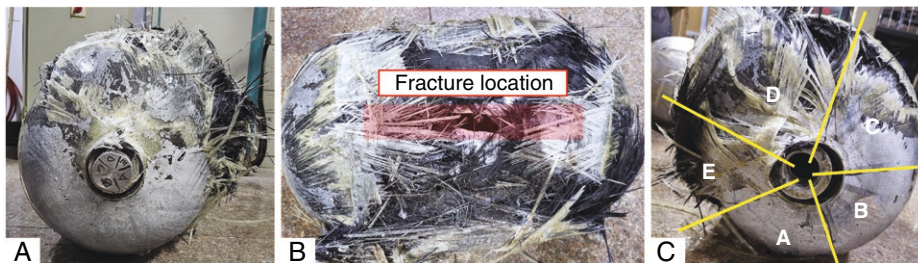
Figure 9 shows the overall shape of the COPV after the explosion. It can be seen that the location of the cylinder explosion is located in the cylindrical part, resulting in a circular rupture between the dome and the cylinder part. The fiber wound layer experienced fractures, while the liner rupture exhibited a tear-like pattern. No debris was generated as a result of the explosion. In summary, based on the preexperimentation of the circumferential direction area division, the burst occurred in the middle section of the area D of the COPV cylinder part, as shown in Fig. 9b.

The industrial CT scanning and hydraulic burst test revealed that the COPV burst crack originated in the middle section of the cylinder in the D area. As described in section 2.3, it can be found that the majority of large-sized delamination defects exist in the D area. Figure 10 reveals that the location of the COPV burst crack and the location of the dense area of large-size delamination defects have a high degree of correspondence. It can be seen that the delamination defects have a certain degree of influence on the crack initiation during the burst test.

Figure 9. Three views of the COPV after the burst test: (a) left view; (b) front view; (c) right view.

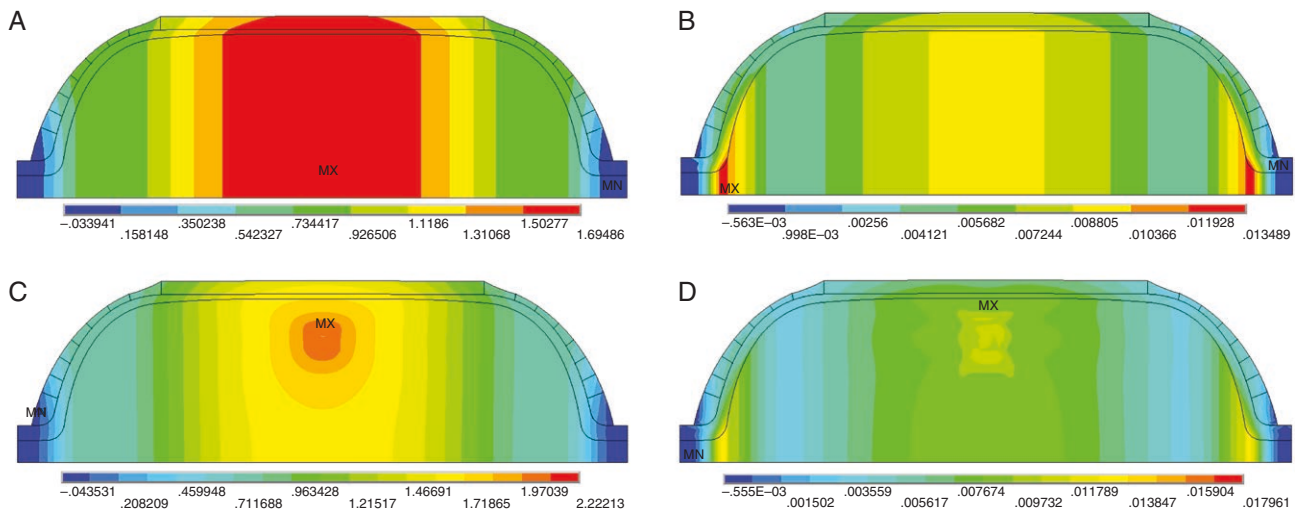
internal pressure of 78.75 MPa. Figure 13a and b shows the radial displacement and circumferential strain distributions for the pristine model, respectively, while Fig. 13c and d illustrates the radial displacement and circumferential strain for the delamination defect model. From the radial displacement and circumferential strain contour plots, it is evident that the cylindrical section of the COPV is identified as the dangerous region, as it experiences significantly higher stress and strain values compared to the domes. Thus, for type III hydrogen storage COPVs, the cylindrical part is considered the critical region during the pressurization process. To predict the burst pressure of the COPV, we further analyzed the stress distribution in the filament winding layer of its cylindrical section.

The delamination defects within the filament winding layer of the cylinder alter the overall structural strength consistency, particularly in the out-of-plane direction. As shown in the contour plots mentioned above, compared to the pristine model, the results for the model with delamination defect show varying degrees of distortion in out-of-plane displacement and circumferential strain at the defect location. As the internal pressure increases during the loading process, these distortion characteristics become more pronounced at the defect sites, leading to a reduction in the burst pressure of the COPV. This, in turn, induces crack initiation at the defect locations, ultimately causing the COPV to fail.

**Figure 13.** FEA results (78.75 MPa): (a) radial displacement of pristine model; (b) circumferential strain of pristine model; (c) radial displacement of model with delamination defect; (d) circumferential strain of model with delamination defect.

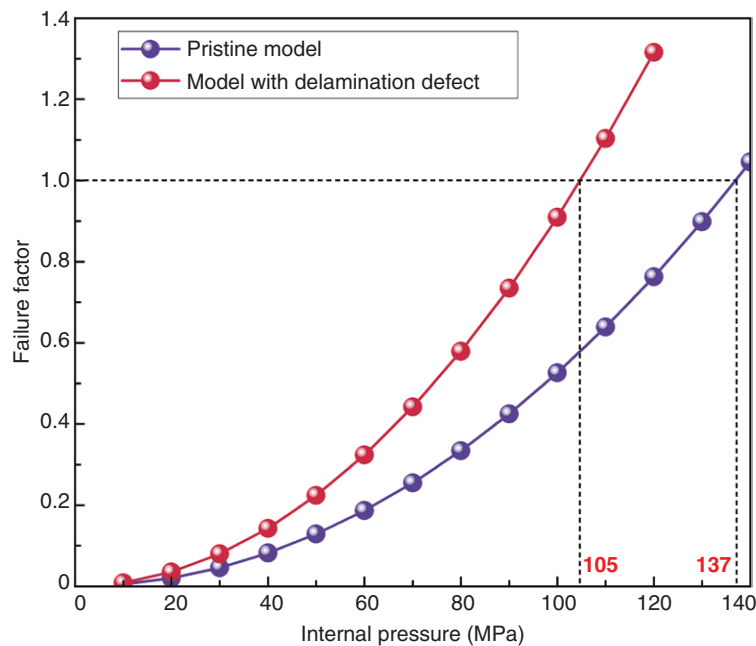
Based on the stresses in various directions obtained from the cylinder model analysis and the Tsai-Wu failure criterion, Fig. 14 indicates that the burst pressure of the pristine model is 137 MPa, while the burst pressure of the model with delamination defect is 105 MPa. As shown in Section 3, the experimentally measured burst pressure of the cylinder is 115.5 MPa, which deviates by 18.6% from the pristine model prediction and by 9.09% from the model with delamination defects.

It can be seen that both the pristine model and the model with delamination defect exhibit a prediction error of 9% to 20% compared to the experimentally measured burst pressure. This discrepancy arises primarily because the pristine model assumes the material to be in a completely ideal state, with no defects or damage, leading to a predicted burst pressure that is 18.6% higher than the measured value. For the model with delamination defects, the modeling of defects does not perfectly match the actual conditions; the spacing between delamination in the model is larger than that detected by industrial CT scanning, resulting in a greater impact on the overall structure of the cylinder. Consequently, the predicted burst pressure is 9.09% lower than the experimentally measured value.

**Figure 14.** Variation of the failure factor with different inner pressures.
