# Investigation of crack initiation during the burst test of hydrogen storage composite overwrapped pressure vessels

Changchen Liu<sup>ID</sup>, Zhihui Ouyang, Jiexiang Yu and Li Ma\*

Institute of Applied Mechanics, Zhejiang University of Technology, Hangzhou 310018, China

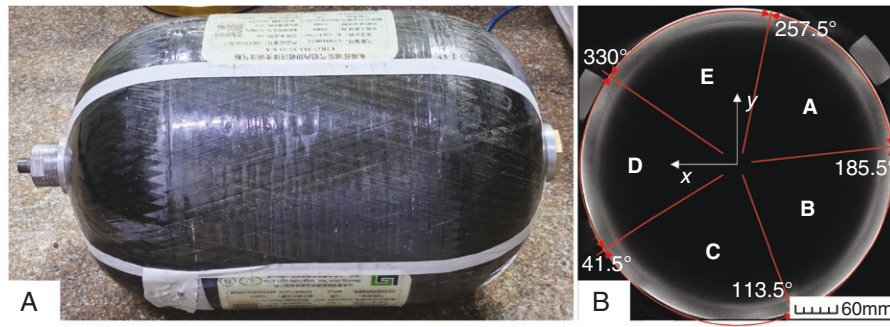
Figure 1 shows an experimental type III hydrogen storage COPV (product number CHG3-383-55-35 S/A, according to the Chinese standard GB/T 35544 [14]) with an outer diameter of 420 mm, a length of 700 mm, a volume of 55 L, and a nominal working pressure of 35 MPa, which includes 40 layers of carbon fiber wound and an aluminum liner.

**Figure 1.** (a) Experimental COPV; (b) axial cross-section of cylinder.

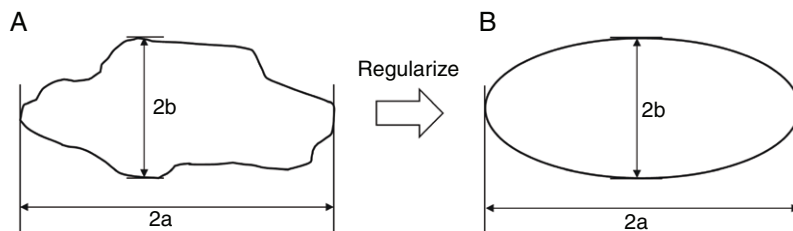
In order to facilitate further statistical analysis of the CT scan results, the delamination defects from the CT scans were regularized, as shown in Fig. 5, into standard elliptical defects with the long semiaxis of  $a$  and the short semiaxis of  $b$  according to the shape and size characteristics. The area of the delamination defects can be further estimated according to Equation (1).

Figure 5. Regularization of defects: (a) shape of real defect; (b) regularized shape of defect.

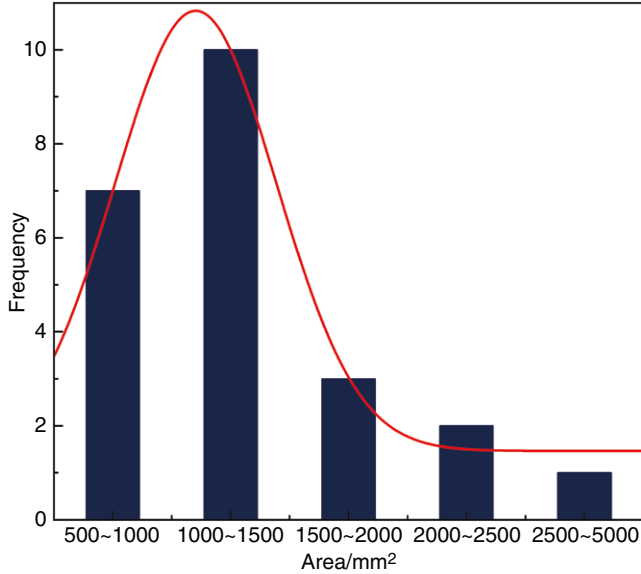
Figure 7. Statistical law of defects (area >500 mm<sup>2</sup>).

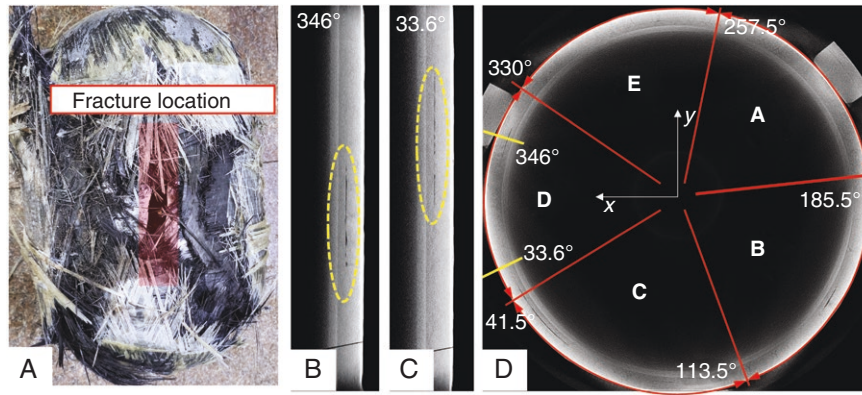
The industrial CT scanning and hydraulic burst test revealed that the COPV burst crack originated in the middle section of the cylinder in the D area. As described in section 2.3, it can be found that the majority of large-sized delamination defects exist in the D area. Figure 10 reveals that the location of the COPV burst crack and the location of the dense area of large-size delamination defects have a high degree of correspondence. It can be seen that the delamination defects have a certain degree of influence on the crack initiation during the burst test.

**Figure 10.** Comparison of measurements with burst test of the COPV.

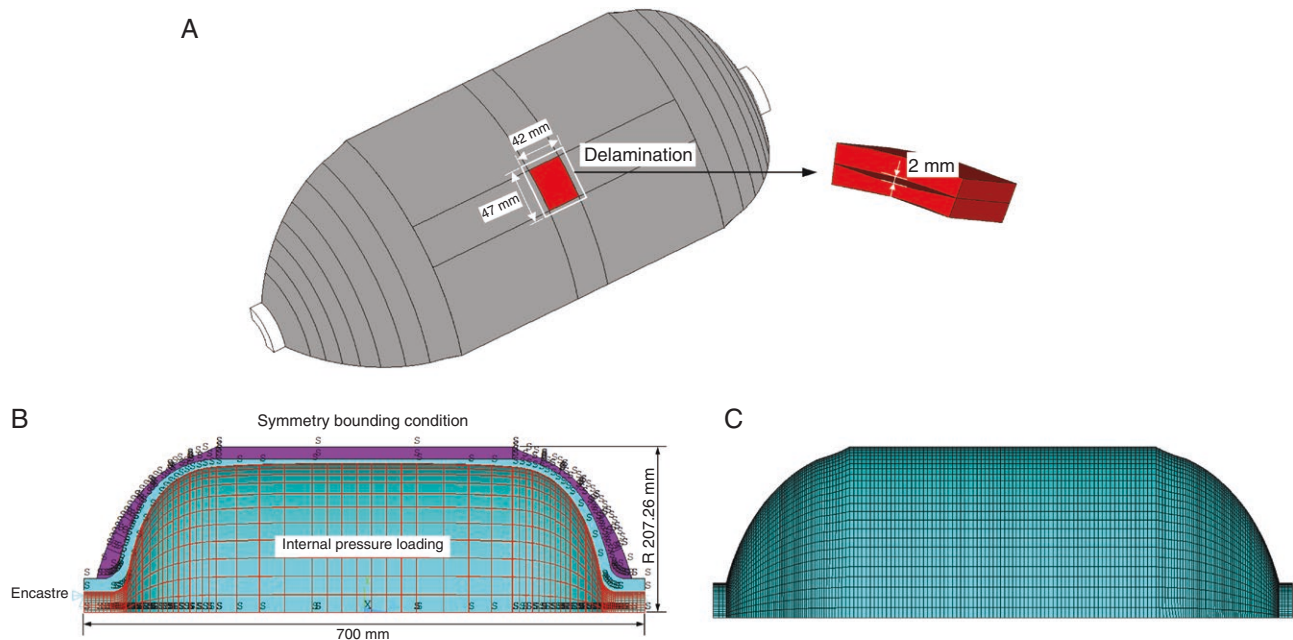
Considering the symmetry of the COPV structure, a one-quarter-scale FEA (finite element analysis) model is built in ANSYS. Based on industrial CT scanning, a crack-like delamination defect, as shown in Fig. 12a, was incorporated into the model, distinguishing it from the ideal cylinder model. The boundary conditions are applied as shown in Fig. 12b. According to the 3D equivalent theory proposed in section 4.1, the equivalent

Figure 12. (a) One-quarter-scale FEA model of the COPV with delamination defect; (b) boundary conditions; (c) model after meshing.
